IMPROVING INSPECTIONS OF NYC TRANSIT STATIONS

Barry L. Kluger
MTA Inspector General
State of New York

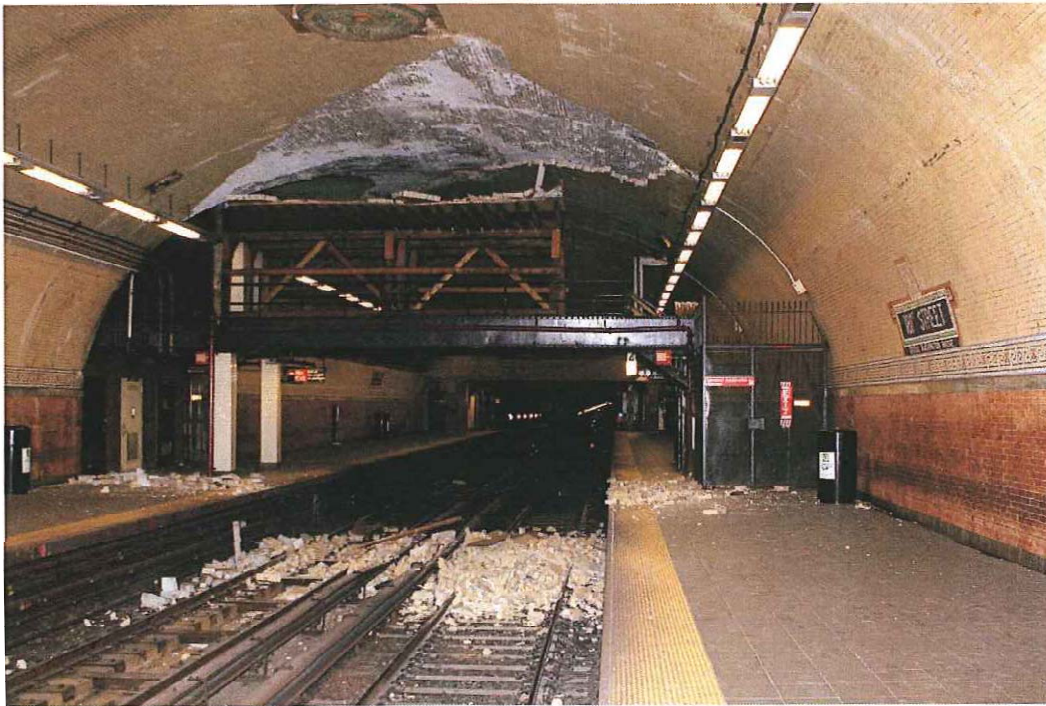
On August 16, 2009, a 30-foot by 30-foot section of the brick ceiling at the 181st Street Station on the IRT **1** Line fell onto the tracks and the adjacent platforms. Subway service was immediately suspended, and did not resume until August 31, after NYC Transit had temporarily secured the ceiling to protect customers and trains from any additional falling debris.³ As of May 6, 2010, approximately \$6.1 million had been spent on emergency stabilization and safety measures,⁴ and NYC Transit currently projects a total cost of \$16.5 million to ensure customer safety until the ceiling is permanently repaired.

181st Street Station, Following August 16, 2009 Ceiling Collapse

During the course of the inspection, the MOW inspector climbed atop the wooden shield and found fallen ceiling bricks there. He also determined that a larger area of the ceiling was deteriorated and in danger of falling onto the wooden shield. He recommended that permanent repair of the ceiling be added to a future CPM contract. The Assistant Chief for MOW's annual and on-call inspectors made telephone and written requests of CPM between September 2006 and June 2007 that the ceiling repairs be included in a then-current capital project (Contract A-36004) to construct scrubber rooms at the 181st Station.⁸ In July 2007, CPM formally rejected the request, because the ceiling repairs would require a conservationist and specialized labor and was beyond the scope of work for the scrubber room contract.

The large temporary shield that had been installed in 2000 to prevent bricks from falling to the platforms and tracks almost completely obstructed inspectors' views of the ceiling's problem area and hindered visual inspection. The presence of this shield should have alerted inspectors that a problem existed, and triggered a thorough investigation, including an up-close inspection of the area above the shield. However, none of the inspectors responsible for assessing the condition of the station ever reported the shield or questioned its presence.

1. MOW and CPM should incorporate into their respective inspection guidelines the requirement that (a) inspectors note when an area is not visible because of an obstruction, and (b) a more thorough up-close inspection of any area so noted be performed shortly thereafter.

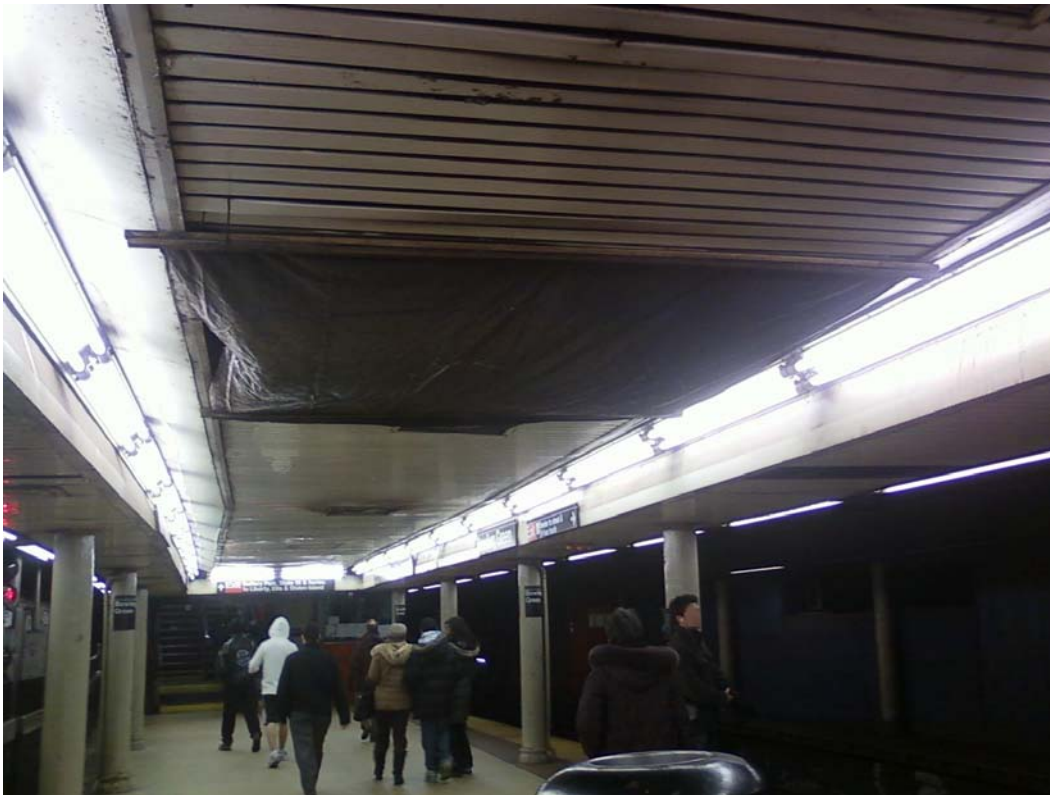
On October 29, 2008, yet another section of the hung metal ceiling fell at the Bowling Green Station. Again, fortunately, no one was injured. Station Maintenance completed repairs on this section of the ceiling on November 20, 2008. However, water leakage continues throughout the station, and, as of our observations on February 17, 2010, at least a dozen sections of the hung metal ceiling are corroded, bent, or missing entirely.

Bowling Green Station with Missing Ceiling Panels, February 17, 2010

NYC Transit does not maintain a list of stations that have been outfitted with hung metal ceilings. However, a CPM Design Manager, with about 25 years of experience in transit station design, told us that there are at least nine stations, including Bowling Green, with hung metal ceilings.¹⁴ We reviewed Station Maintenance's records for these stations and found that a portion of the hung metal ceilings at five of the eight other locations had fallen onto the platform one or more times during the last four years. The apparent reason for these failures is ceiling support assemblies that have been weakened by water infiltration.

For example, CPM's station component inspection of the Bowling Green Station was conducted in September 2007. Its report noted that water was leaking from the ceiling above the southbound platform and that some metal ceiling panels were missing. Yet, the ceiling above the southbound platform was given a rating of 2.5, thus indicating that the structure functioned as designed and that the particular component examined had minor to moderate deterioration. Because of the lack of coordination between CPM and MOW inspectors, the CPM station consultant was unaware of the ceiling failure that had occurred just five months before his inspection. Furthermore, one year after CPM's component inspection, a portion of the hung metal ceiling fell again.

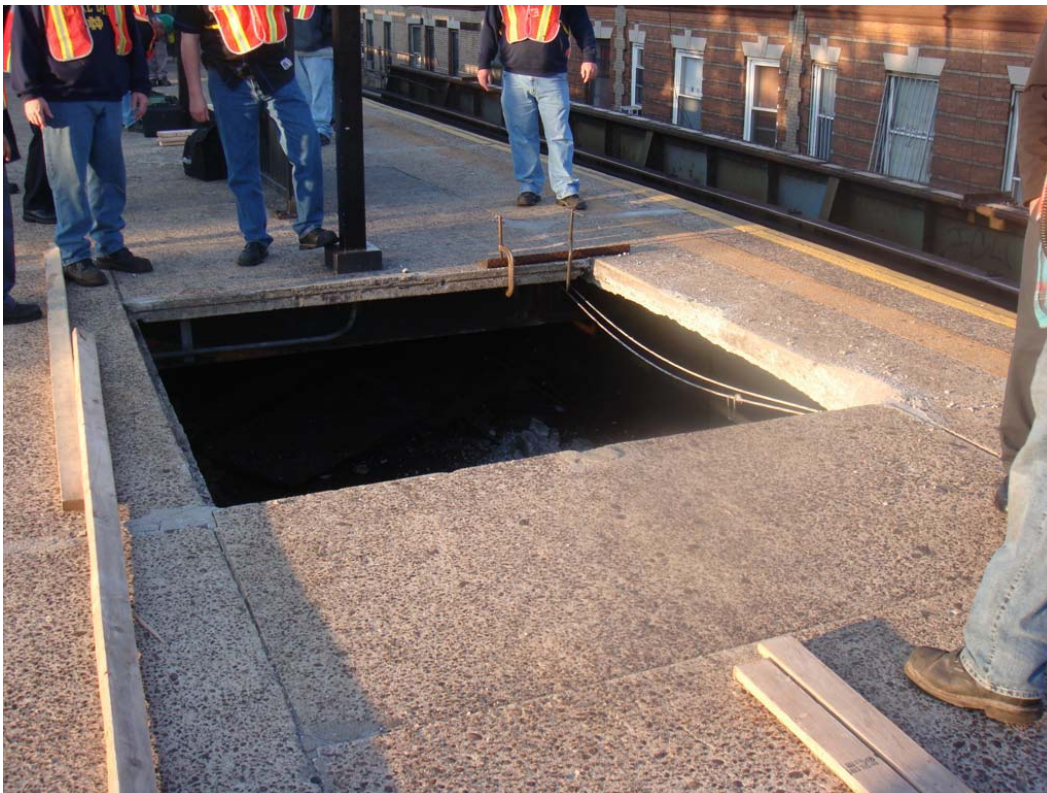
At approximately 2:21 a.m. on May 12, 2009, an 8-foot by 4-foot precast concrete section broke loose from the platform of a NYC Transit elevated station and crashed 25 feet to the street below. The incident took place on the southbound platform at the 18th Avenue Station of the **F** Line. Fortunately, no one was injured and no vehicles beneath the platform were damaged. MOW concluded that an adjacent concrete panel of the same size was also in danger of collapse; its removal of this second panel left an 8-foot by 8-foot hole in the platform.

Collapsed Section of 18th Avenue Station Platform, May 12, 2009

MOW determined that the collapse was due to a failure of the platform panel's concrete support structure. Upon further investigation, MOW concluded that the supporting structures of the station platforms, dating from the 1960s, had been poorly designed. In order to ensure that future failure of a support element would not cause additional platform panels to fall, MOW added steel supports directly below the panels along the length of the station's two platforms.

that it is possible for any platform panel to fail, and fall to the street below. In our view, therefore, a more comprehensive inspection of elevated stations is necessary. MOW should inspect the concrete components of elevated stations on an annual basis. CPM should also ensure that its station consultants obtain the information generated from MOW's more comprehensive inspection of elevated stations, so as to better identify and prioritize future capital work.

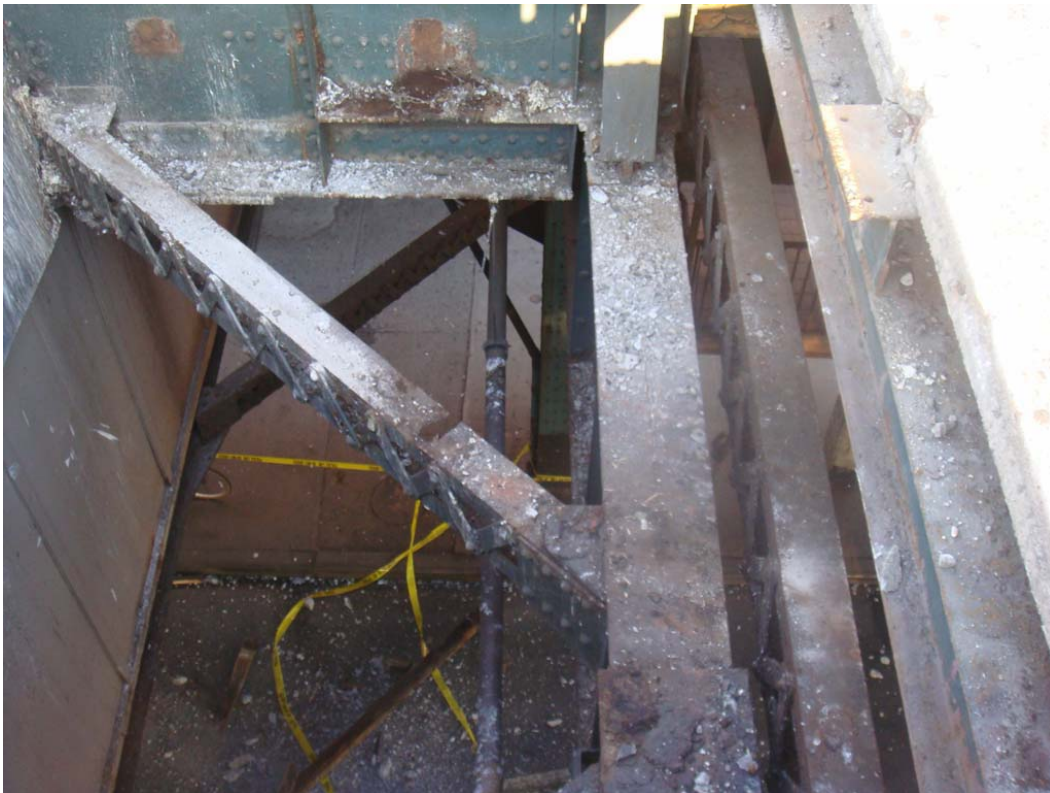
Looking Down at the Street through Platform Hole at the 18th Avenue Station, May 12, 2009
