**Office of the Inspector General**  
Metropolitan Transportation Authority  
Two Penn Plaza, 5<sup>th</sup> Floor  
New York, New York 10121  
212-878-0000

**Re: Inventory Controls at the Long  
Island Rail Road MoW Repair Shop  
MTA/OIG #2016-10**

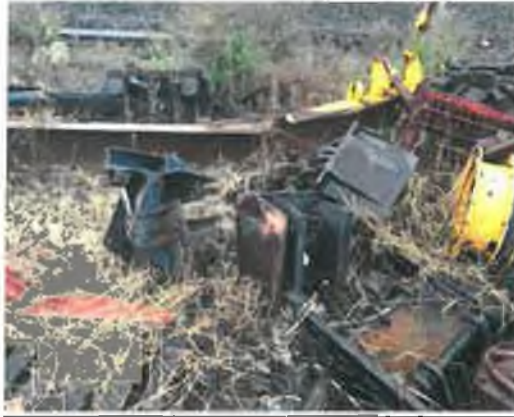
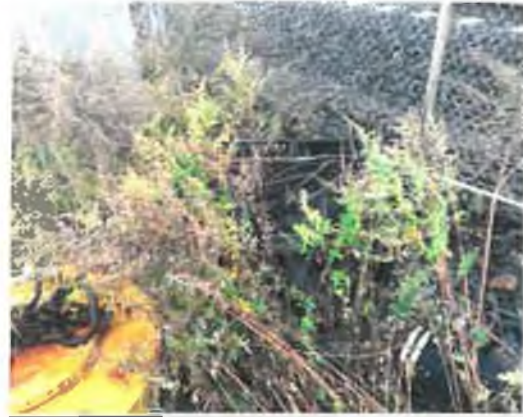
- New materials appeared to be commingled with used items, scrap metal, failed parts waiting to be refurbished, and broken-down equipment kept on the property for salvage. Many steel or other metal items are exposed to the elements and have become dirty or rusted, making it difficult to distinguish whether they are new, old, or obsolete inventory.

- *Engineering management has begun the process of identifying materials that need better protection from the elements and to provide the proper protection as appropriate. Management will also identify obsolete and scrap inventory for disposal in accordance with LIRR policy.*

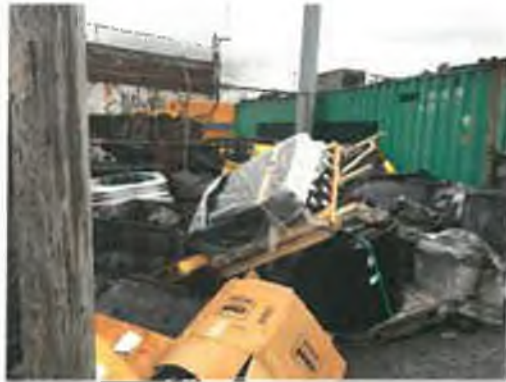
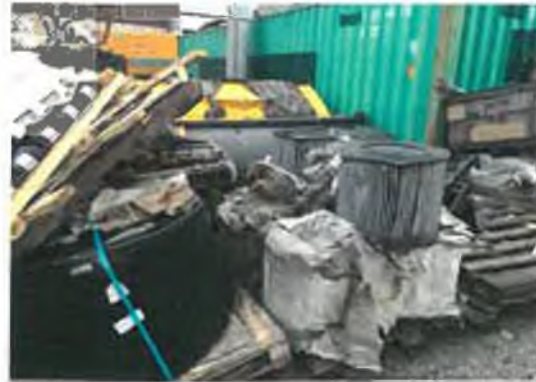
- Materials were not clearly marked and their storage locations within the yard were not identified in the inventory records, thus requiring extensive resources to search for them. For example, our physical count included eight units of part number 9050603, labeled “Tie Crane Head” in the inventory records. These parts were found in three separate locations in the yard, but locating them required significant time from several employees because they were mixed in with other materials or obscured by overgrown vegetation.
- Materials appeared to have been haphazardly tossed on top of each other in a way that could potentially render them unusable or create an unsafe condition.
