## **FIRE SAFETY SYSTEMS IN NYC TRANSIT YARDS – FINAL REPORT**

**Elizabeth Keating**  
Acting MTA Inspector General  
State of New York

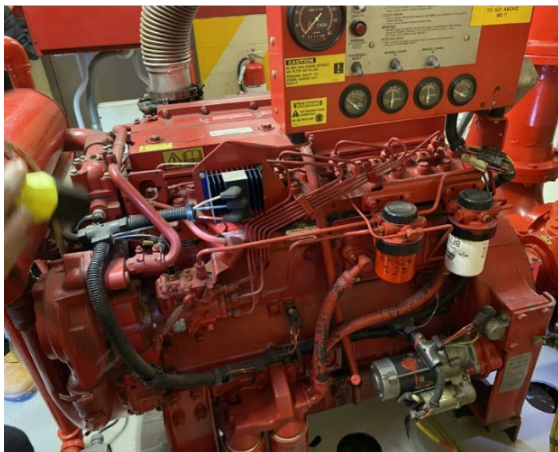
*Photo #1: Diesel Fire Pump located in the Overhaul Shop at Coney Island Yard*

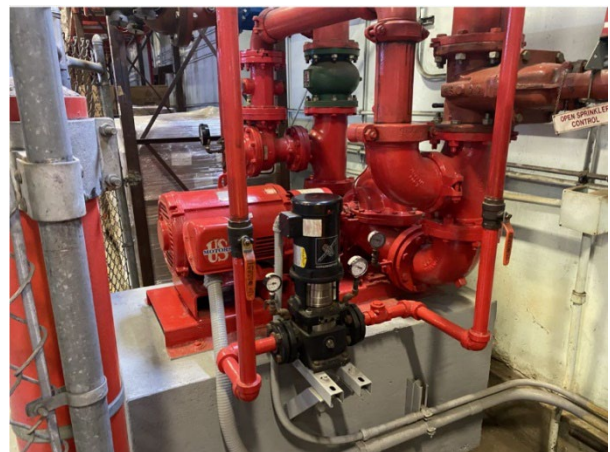
*Photo #2: Electric Fire Pump located in Storeroom #1 at 207<sup>th</sup> Street Yard*

The fire pump failed the independent contractor's test immediately due to insufficient waterflow, as measured by Gallons Per Minute (GPM) readings. The fire pump bears an identification plate stating that readings from three outlet ports must total 750 GPM for the pump to meet requirements; however, the test results only recorded 400 GPM. The volume of water supplied to the fire pump was therefore too low to support adequate fire suppression. Notably, Fire Suppression personnel had not tested the GPM during their March 9 test; instead, they tested only the *pressure* (PSI) of the water supply, being unaware of the GPM requirements necessary for the pump to pass the test. While the identification plate clearly states the GPM requirements, Fire Suppression personnel were never instructed to refer to that information during their tests.

Next, the contractor checked the GPM at a fire hydrant outside the yard property to determine whether the insufficient flow stemmed directly from the NYC water supply or was caused by an issue within the yard's fire loop. The contractor found that the GPM at the street hydrant met requirements; however, two additional hydrants in the yard were tested and found to also have extremely low GPM levels. The contractor therefore suspected an impairment in the loop piping.

To identify the suspected impairment, MOW immediately hired a second contractor, who utilized cameras to probe the section of the fire loop feeding the fire pump. The contractor reported observing severe tuberculation (calcification and mineralization) of the pipe, a condition typically found in pipe of this age and type. Specifically, the contractor found that the pipe was so restricted that only 1.25 inches of the 6-inch diameter pipe was available for water flow. The contractor's report also indicated that due to the age of all the piping, this condition may exist in other sections of the fire loop as well.

Since the contractor issued its report, NYC Transit has had the section of pipe feeding the fire pump replaced. Based on discussions with OIG, the Vice President and Chief Maintenance Officer of MOW then directed personnel to test the volume (GPM) as well as the pressure (PSI) of the incoming water flow at all buildings within the 207<sup>th</sup> Street Yard. MOW personnel first started testing the overhaul shop's standpipes, which provide hose connections for FDNY to use in the event of a fire, in accordance with the building codes in effect at the time the system was installed. Because the overhaul shop was built in the early 1900s, NYC Transit determined that its system falls under 1938 building codes, which only requires that the fixtures maintain 15 PSI when the nearest New York City hydrant is opened to 500 GPM. MOW Engineering also agreed to take GPM readings, but indicated it was for informational purposes only and would have no bearing on the pass/fail status of each standpipe tested. A test was performed on August 18, 2022, and OIG observed GPM measurements ranging from 220 to 300 GPM, which is well below the current NFPA code requirements but complies with 1938 code. OIG also observed one PSI reading at Storeroom #1 below the 1938 code, but at this time, an official test report is still pending from MOW Engineering.

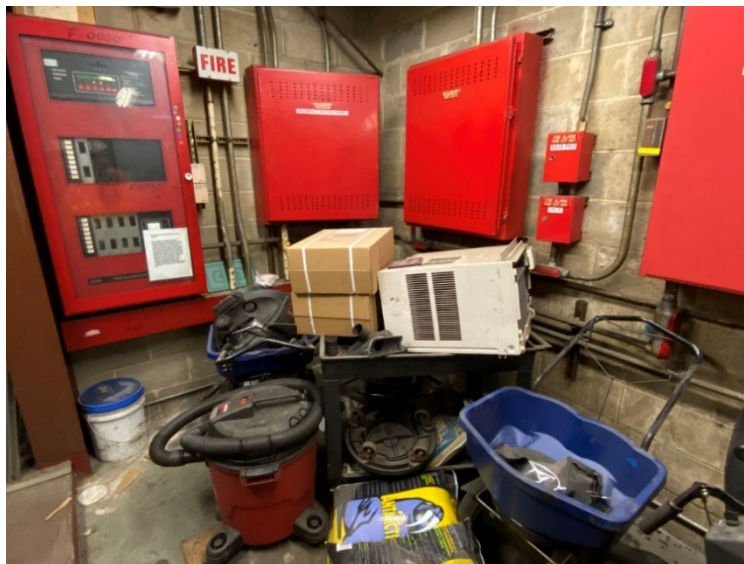
In addition, during OIG's walkthrough, it found several conditions in the yards that did not comply with either the Safety Checklist requirements or the National Fire Protection Association code (NFPA-72). For example, one of the checklist items requires monthly inspections of fire extinguishers. However, OIG observed that many fire extinguishers had not been inspected for several months.

*Photo #3: Access to the FACP in the Coney Island Pneumatic Shop does not have the required 3 feet of clearance per NFPA-72 code requirements.*

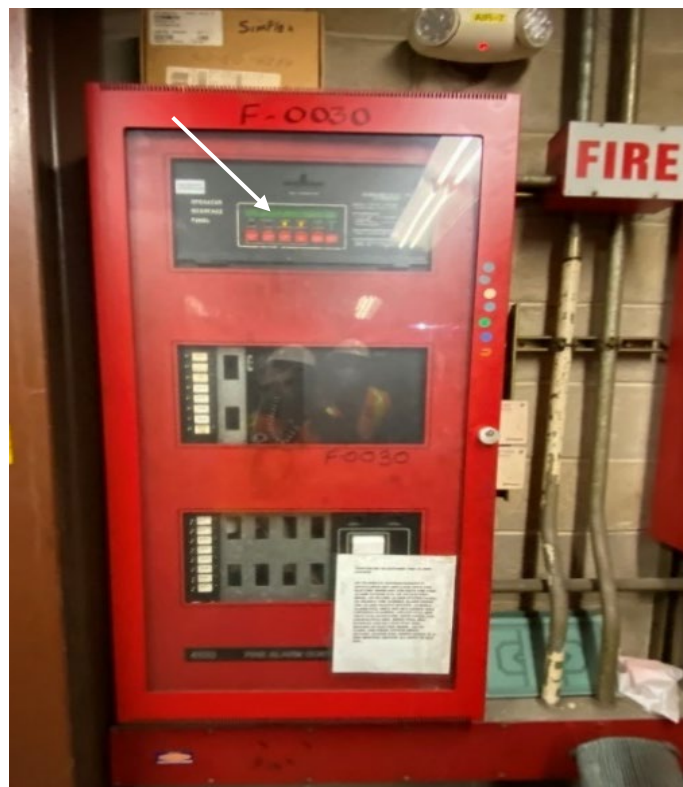
Of the remaining 27 fire alarm systems OIG observed, 21 FACP's were in unoccupied rooms such as closets, storage rooms, or electrical rooms and were not immediately visible. Trouble and supervisory alarms at these locations generate audio-visual alarms at the FACP and, Fire Alarm Remote Annunciator locations, indicating a problem with the alarm system which must be manually reported by facility staff. OIG found that because of the devices' placement in these relatively remote locations, NYC Transit staff do not actively seek out and monitor these alarm systems. Significantly, OIG found that 10 of the 31 facilities showed current trouble conditions, but the building superintendents and other employees OIG spoke with onsite were unaware that the alarms had been activated. (See Photo #4.)

*Photo #4: Fire alarm panel indicating both a trouble and a supervisory alarm (top row, yellow lights) at the Coney Island Yard Pneumatic Shop Electrical Room.*
