## IMPROVING INSPECTIONS OF NYC TRANSIT STATIONS

**Barry L. Kluger**  
MTA Inspector General  
State of New York

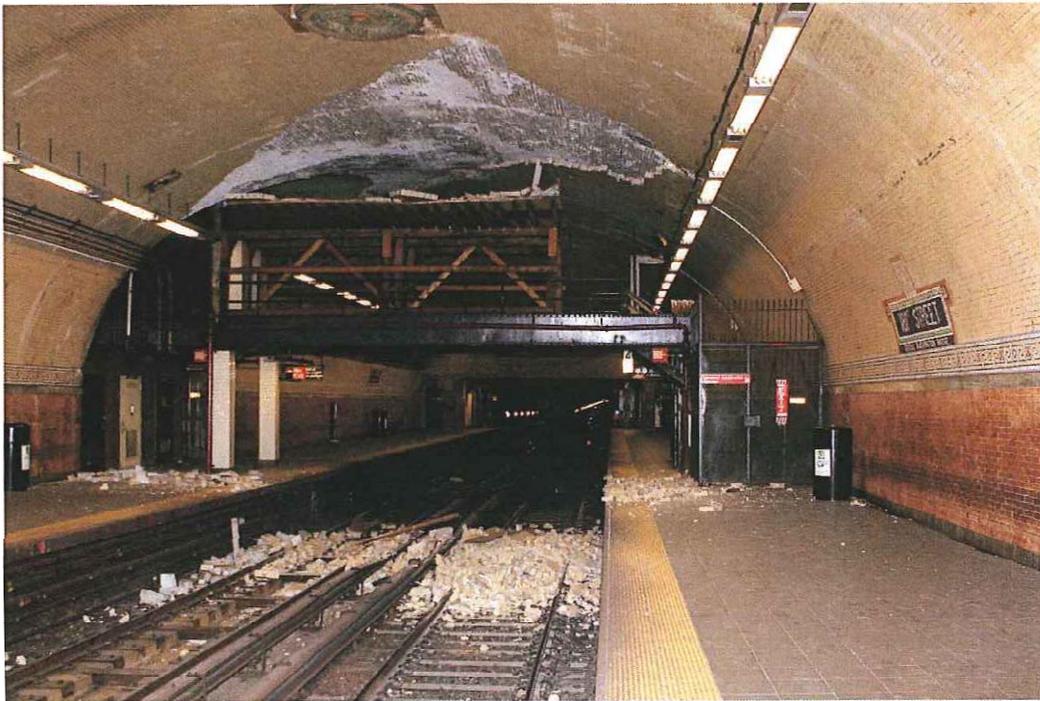
On August 16, 2009, a 30-foot by 30-foot section of the brick ceiling at the 181<sup>st</sup> Street Station on the IRT 1 Line fell onto the tracks and the adjacent platforms. Subway service was immediately suspended, and did not resume until August 31, after NYC Transit had temporarily secured the ceiling to protect customers and trains from any additional falling debris.<sup>3</sup> As of May 6, 2010, approximately \$6.1 million had been spent on emergency stabilization and safety measures,<sup>4</sup> and NYC Transit currently projects a total cost of \$16.5 million to ensure customer safety until the ceiling is permanently repaired.

181<sup>st</sup> Street Station, Following August 16, 2009 Ceiling Collapse

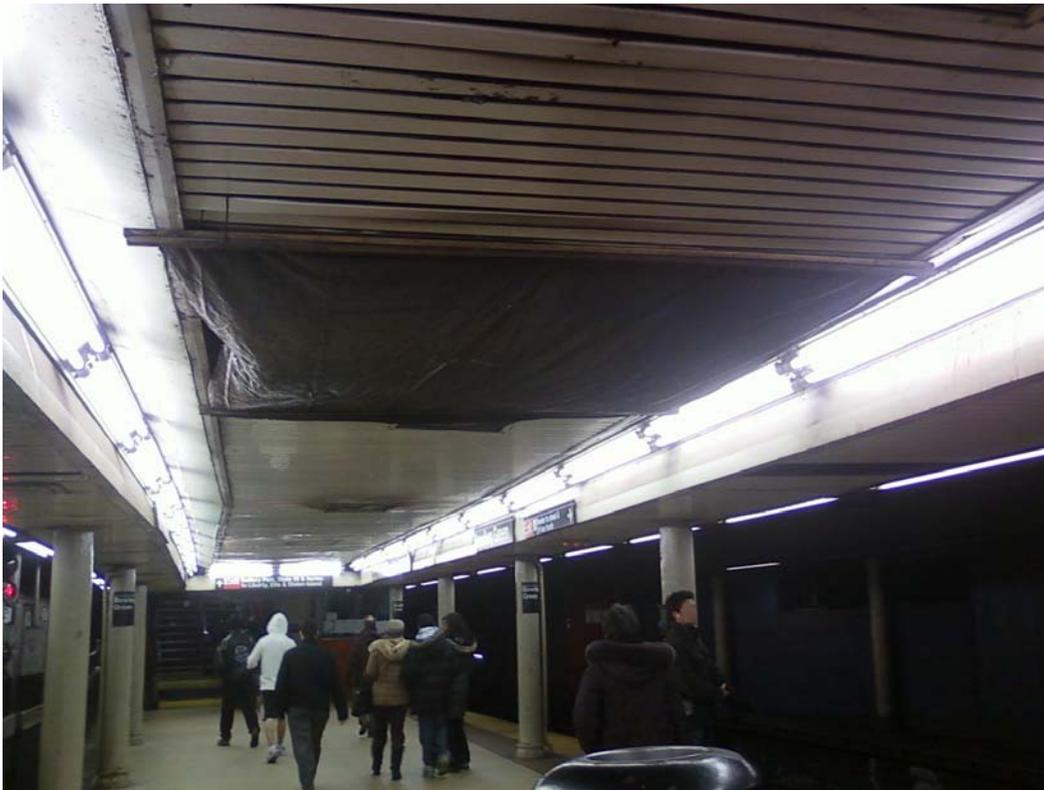
On October 29, 2008, yet another section of the hung metal ceiling fell at the Bowling Green Station. Again, fortunately, no one was injured. Station Maintenance completed repairs on this section of the ceiling on November 20, 2008. However, water leakage continues throughout the station, and, as of our observations on February 17, 2010, at least a dozen sections of the hung metal ceiling are corroded, bent, or missing entirely.

**Bowling Green Station with Missing Ceiling Panels, February 17, 2010**

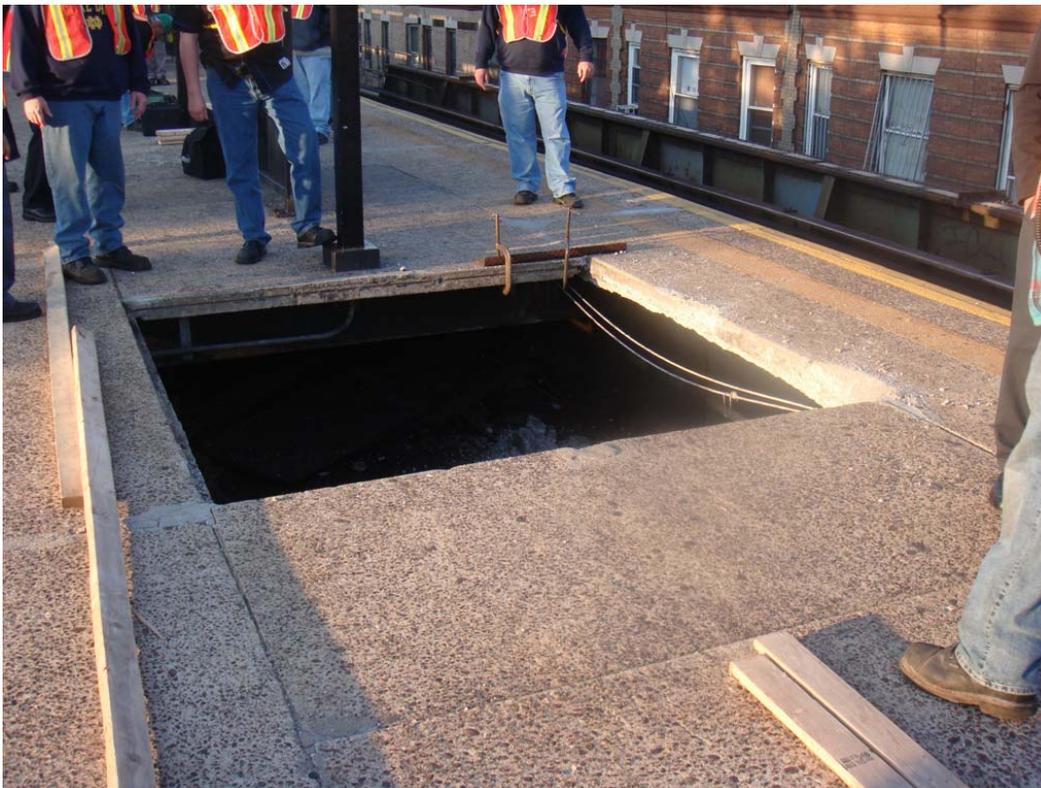
At approximately 2:21 a.m. on May 12, 2009, an 8-foot by 4-foot precast concrete section broke loose from the platform of a NYC Transit elevated station and crashed 25 feet to the street below. The incident took place on the southbound platform at the 18<sup>th</sup> Avenue Station of the **F** Line. Fortunately, no one was injured and no vehicles beneath the platform were damaged. MOW concluded that an adjacent concrete panel of the same size was also in danger of collapse; its removal of this second panel left an 8-foot by 8-foot hole in the platform.

**Collapsed Section of 18<sup>th</sup> Avenue Station Platform, May 12, 2009**

MOW determined that the collapse was due to a failure of the platform panel's concrete support structure. Upon further investigation, MOW concluded that the supporting structures of the station platforms, dating from the 1960s, had been poorly designed. In order to ensure that future failure of a support element would not cause additional platform panels to fall, MOW added steel supports directly below the panels along the length of the station's two platforms.

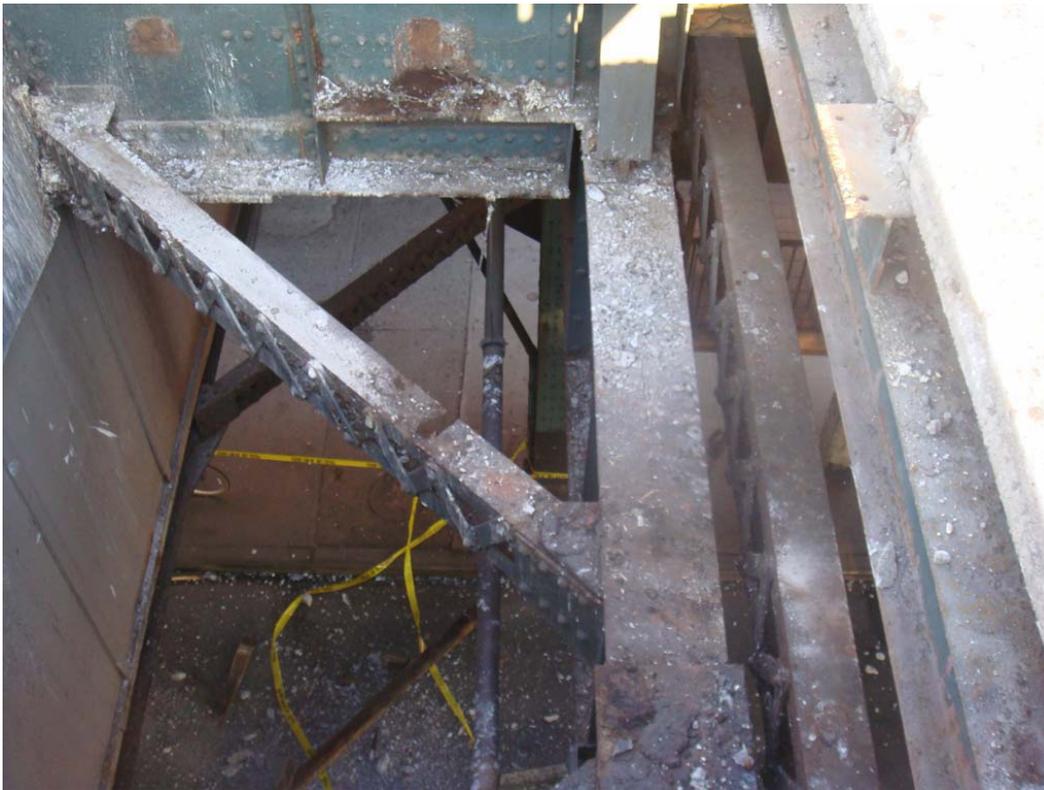
Looking Down at the Street through Platform Hole at the 18<sup>th</sup> Avenue Station, May 12, 2009
