MINIMIZING ADDITIONAL WORK ORDERS ON NYC TRANSIT CAPITAL PROJECTS

Barry L. Kluger
MTA Inspector General
State of New York

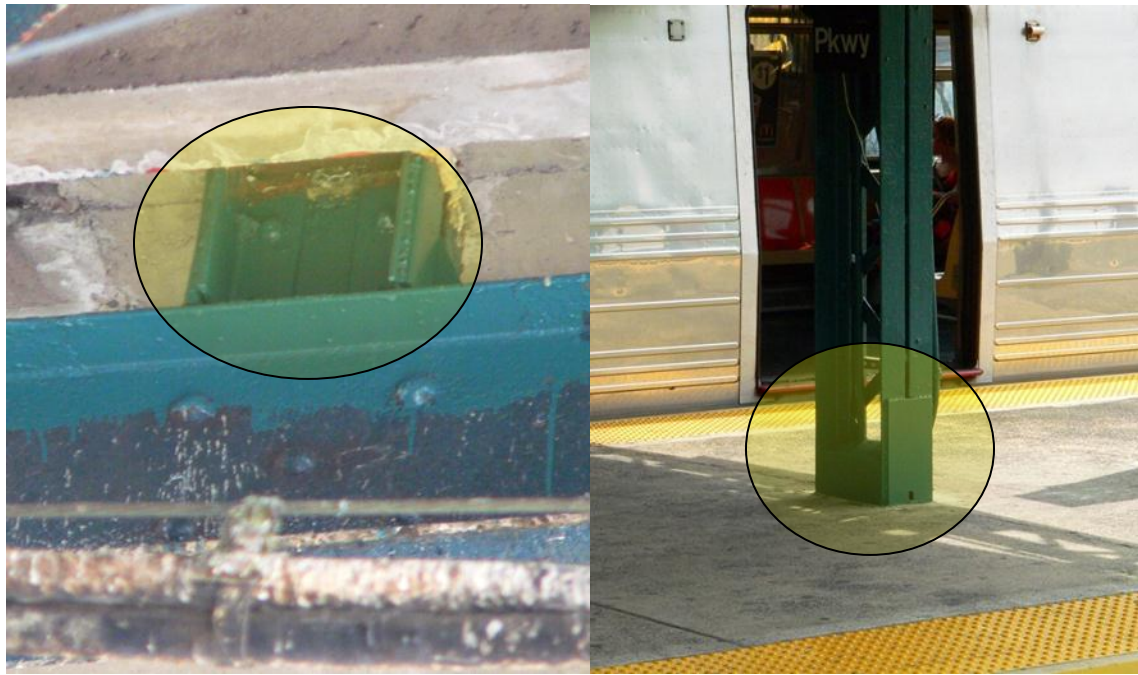
The pictures in Figure 2 and Figure 3, which were taken during our site visits and show the location of the additional repairs, help illustrate the deficiencies of Dewberry's inspection techniques. Almost all of the added canopy column base repairs, which totaled \$933,000, had to be made to the steel below the station platform level. The first picture in Figure 2 depicts the structure below the platform. We found during our site visits that these structures are only partially visible from the street or the platform. Similarly, the picture in Figure 3 shows that the steel girders that support the station platforms are also only partially visible from the street, and not visible at all from the platform. Additional platform girder repairs totaled \$210,000. Had Dewberry personnel employed inspection methods such as using bucket trucks and walking on the tracks, they would have been in position to identify the defects in these structural components, as required by the contract.

**Figure 2: Examples of Repaired Column Bases
(View from Below Station on Left; and Side View on Right)**

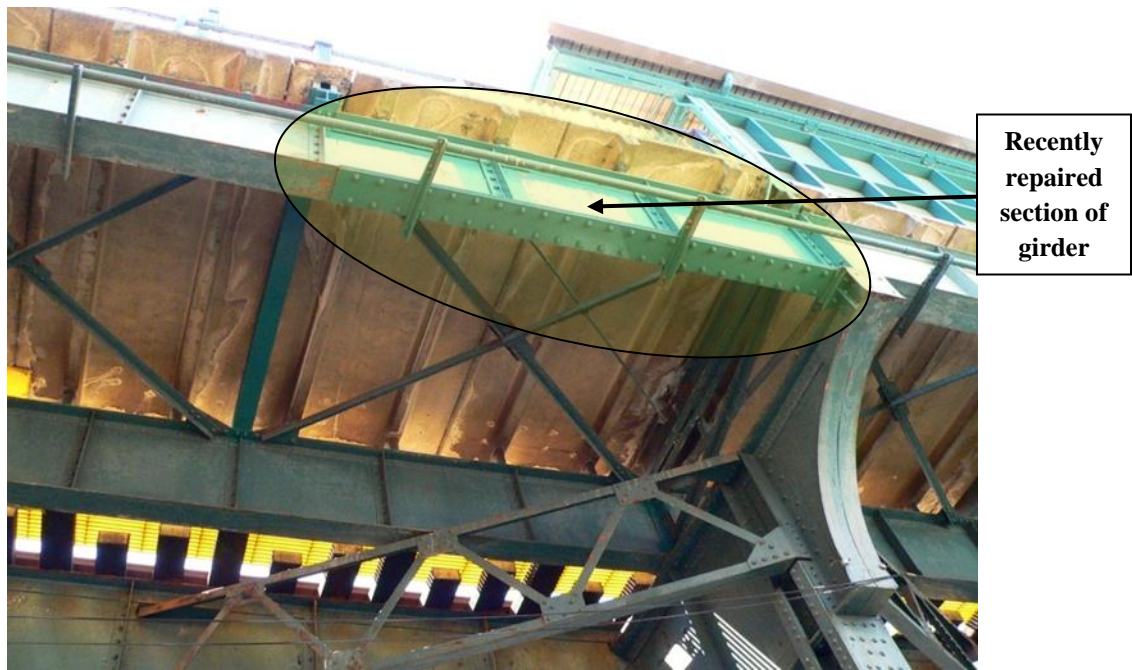
Figure 3: Example of steel girder used to support one of the elevated station platforms at 55th Street on the D Line, viewed from street level

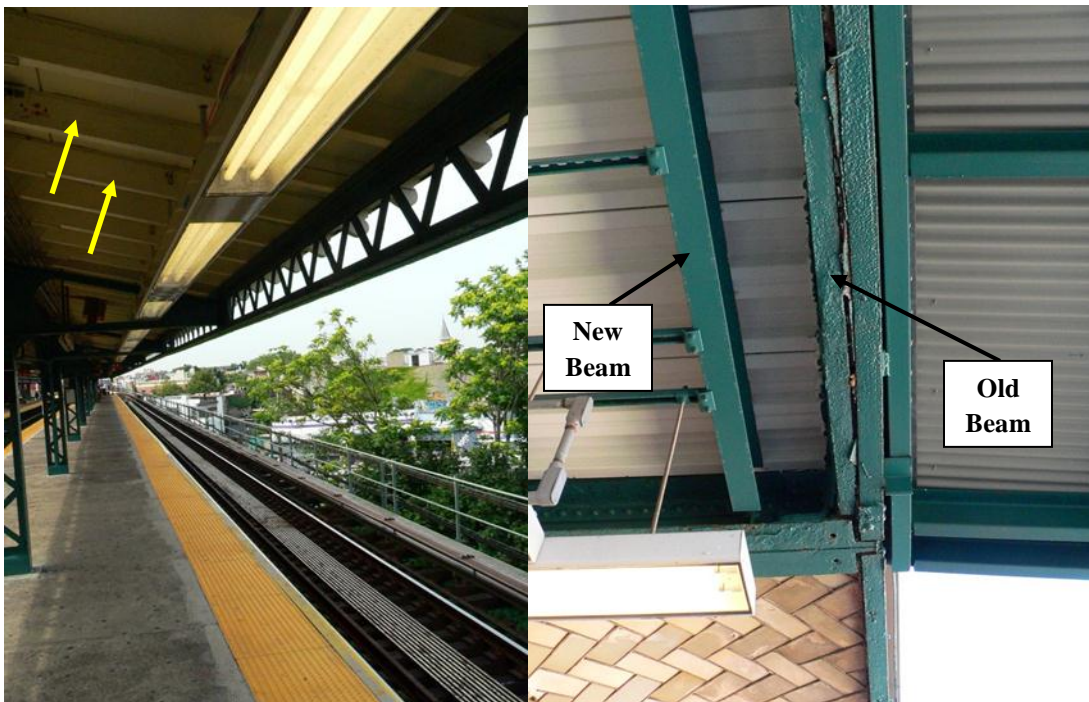
Furthermore, not only did Dewberry fail to perform more advanced inspection methods, we found during our site visits that many of the components that had other defects that were missed and later added through AWOs were entirely visible even during our simple walk-through of the structures and facilities. Presumably, the consultant inspectors should have seen the defects in these components during their inspections, even without techniques beyond simple walk-throughs. As illustrated in the pictures in the following figures that we took during our site visits, this is clearly the case regarding the additional repairs for canopy wood rafters (Figure 4); steel beams that support new platform panels (Figure 5); and entry posts and landing pads at the bottom of station stairs (Figure 6). The additional repairs for these three categories totaled \$465,500.⁹

Figure 4: Canopy wood rafters are visible from the station platform.

Figure 5: New and old, corroded floor support beams are clearly visible from the station mezzanine

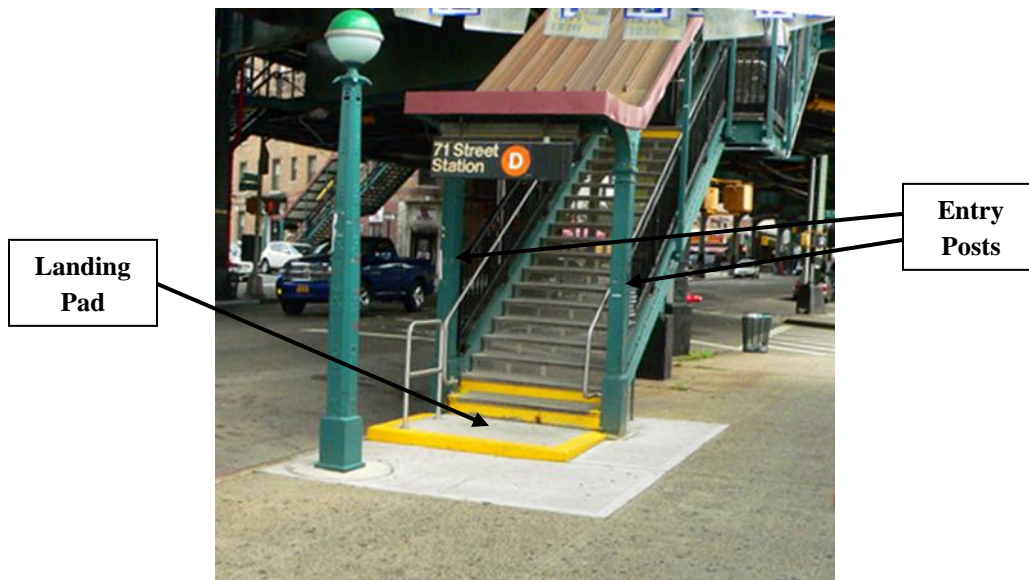
Figure 6: Example of entry posts and landing pad at a station entrance.

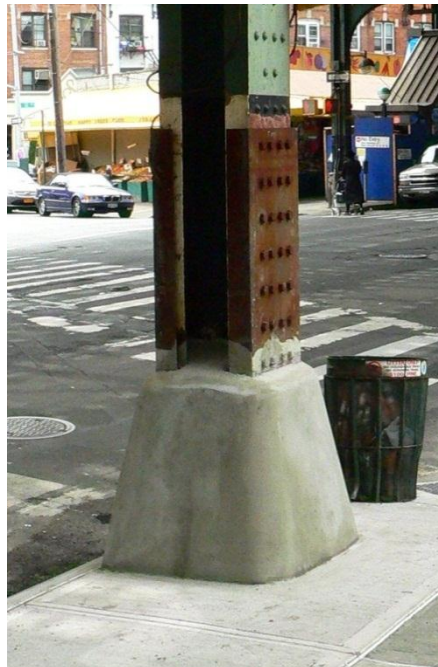
The West End Rehabilitation included repair of street-level columns that support line structures. Under CPM's direction, and consistent with the contract provision regarding line structures (see footnote 8), Dewberry (Urbahn Architect's sub-consultant) relied exclusively on MOW Engineering's annual inspection reports to prepare the designs, as well as the associated drawings and specifications required for the repair of these line structures. As shown in Figure 7 below, column bases are enclosed in concrete. The only way Dewberry could have assessed with absolute certainty the underlying condition of the column bases is if NYC Transit had authorized removal of the concrete enclosure from the approximately 1,100 column bases included in this project to expose the underlying steel. While such an approach by NYC Transit would not have been practical at that time, it is also true that performing destructive testing on a smaller sample of columns leaves some degree of uncertainty as to the condition of the underlying steel.¹⁴ Given these limitations, NYC Transit could not determine with certainty the type or number of repairs that it would need before it bid the contracts.

Figure 7: Concrete-Covered Column Base

A more practical alternative for NYC Transit than post-award negotiation, one that would have minimized the potential for AWOs, would have had the agency prepare a comprehensive list of conceivable repairs of the concrete-encased steel and agree on their prices in advance before awarding the contracts. However, according to the senior program executive for CPM's Infrastructure and Facilities division, NYC Transit's policy is generally to award contracts for a single, lump-sum price so that the contract amount does not change when the actual number of repairs varies from the number estimated in the contract. The agency never seriously considered a quantity-based, pre-award price determination to be an option for this or any other contract that required structural steel repairs. Consequently, the project was saddled with almost \$1.4 million in unnecessary AWOs and 12 months of project delays that disrupted the community. What follows is our explanation of how the NYC Transit approach to contracting for the project's column base repairs resulted in these unnecessary AWOs.

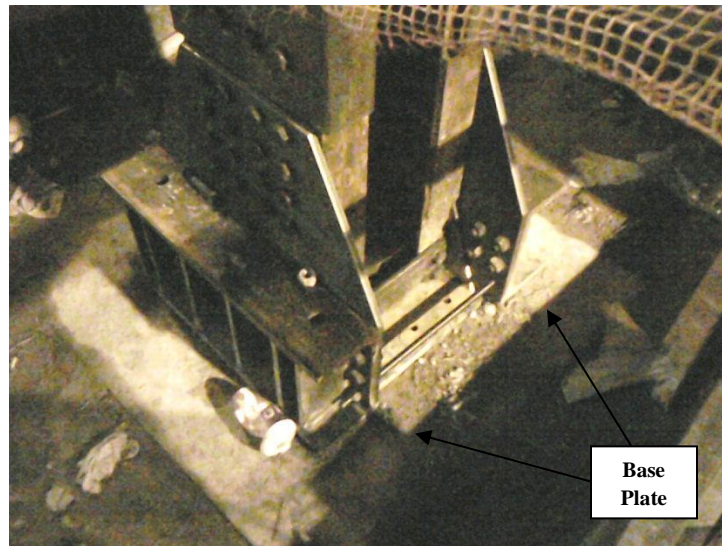
Type V repairs address the lowest part of a column and include the steel base plate that a column rests upon (see Figure 8 on following page). The defects involved in this type of repair are completely obscured from view until the concrete encasement is removed-which normally occurs after the contract award-again resulting in a pre-award estimate that is inherently imprecise. CPM estimated that the contractors would need to complete 118 Type V repairs. Once construction work began and concrete was removed from the column bases, it again became

apparent—predictably—that the number of repairs actually needed exceeded the estimate. The extra Type V repairs required another \$578,000 in AWOs.

Figure 8: Lowest Part of a Fully Exposed Column Base

Compounding the considerable cost premium of these AWOs, the agency delayed the eventual repair process by not pre-establishing an itemized list of conceivable Type V repairs. Rather than a pre-established list, the contracts contemplated that the construction contractors, at the time they were ready to perform the repairs, would remove the concrete encasements from all the bases, determine which ones needed repair and the type of repair needed, and then present to the agency a list of proposed repairs at a proposed cost.
