IMPROVING STRUCTURAL INSPECTIONS AT MTA NEW YORK CITY TRANSIT

Barry L. Kluger
MTA Inspector General
State of New York

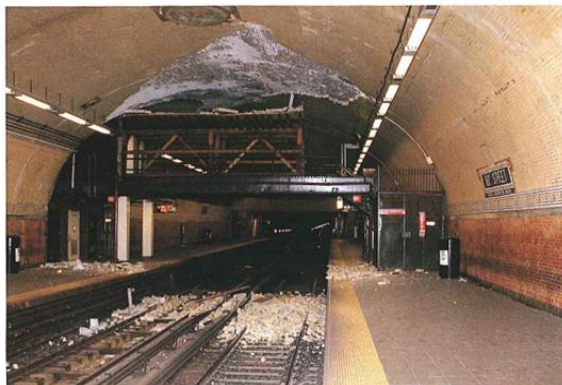
181st Street Station, Following August 16, 2009 Ceiling Collapse

Recommendation 3: In accordance with our 2010 recommendation, which NYC Transit accepted, the agency must promptly complete all planning and other necessary preliminary measures and perform regular and timely inspections of masonry and brick arch ceilings, and structural ceilings obscured by hung panels.

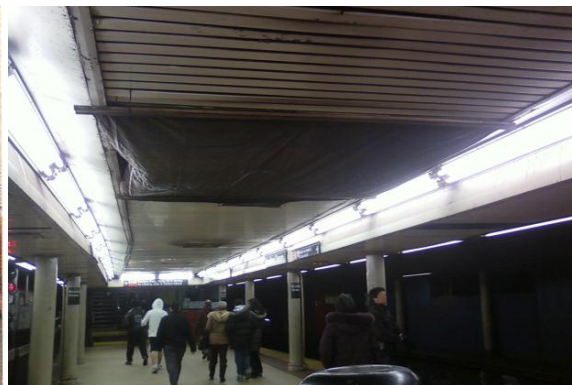
Bowling Green Station with Missing Ceiling Panels, February 17, 2010

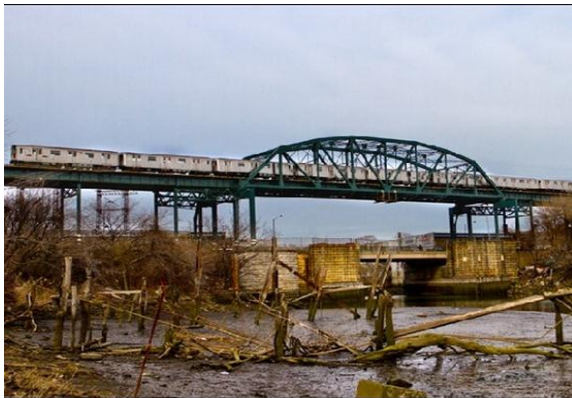
Bronx River Truss Bridge

The structural inspection task force has set an inspection cycle of five years for truss bridges,²¹ elevated structures higher than 35 feet above street level (high elevated structures), and underwater structures. NYC Transit has identified 11 truss bridges, ten high elevated structures, and four underwater structures²² that should be regularly inspected; these inspections are currently scheduled to begin in 2013.

Recommendation 4: NYC Transit must adhere to its own rules requiring comprehensive inspections of all truss bridges, high elevated structures, and underwater structures every five years. The agency should also broaden the category of bridges to be inspected to include the Stillwell Avenue Bridge and any other similar structure.

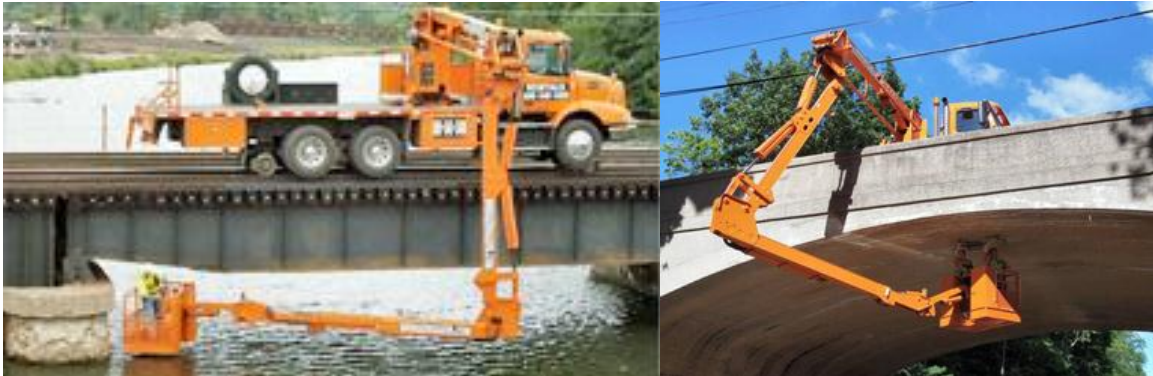
NYC Transit management officials informed us that the agency must hire consultants to inspect the undersides and supports of its bridges, viaducts, and high elevated structures because it does not have the necessary equipment to perform such inspections. Other transportation agencies, including MTA's own Metro-North Railroad, use specialized trucks and trains for this purpose. These vehicles have jointed mechanical arms that pivot under the structure on which the vehicles ride. A large bucket or work platform positioned at the end of the mechanical arm holds the inspectors comfortably upright, giving them up-close views of a structure's underside.²³ OIG believes that NYC Transit may benefit from using this equipment in its inspections, and may be

**Example of a Specialized Vehicle that
Allows Up-close Inspections**

Recommendation 5: NYC Transit should consider (1) using specialized track vehicles to enable up-close inspections of the undersides of bridges, viaducts, and high elevated structures and (2) obtaining such equipment by purchase or through a sharing agreement with the MTA commuter railroads for use by its own inspectors, or contracting with consultants who use such equipment.
